OPERATING EXPERIENCE WEEKLY SUMMARY

Office of Nuclear and Facility Safety

December 11 - December 17, 1998

Summary 98-50

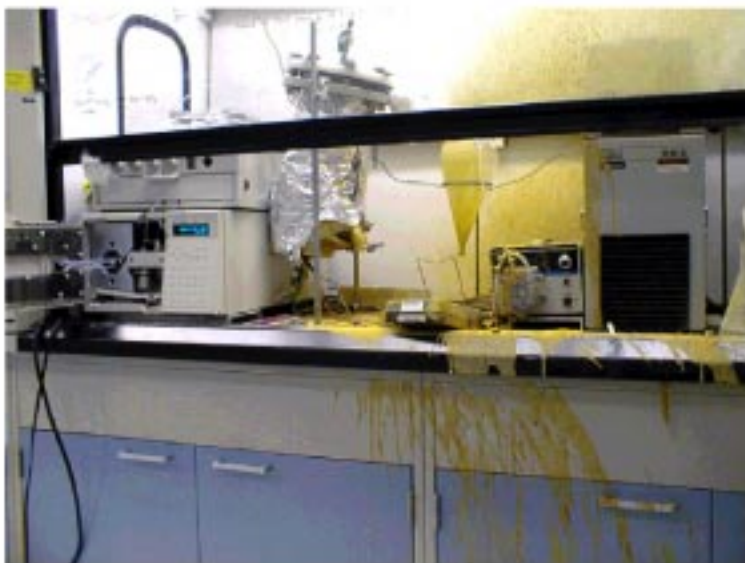
Figure 5-1. Fume Hood and Ruptured Vessel

Investigators have not determined the cause of the vessel rupture. Figure 5-1 shows the fume hood and the ruptured vessel. Investigators determined that the experiment had been running for several hours without incident when the researcher left the laboratory. They also determined that approximately 1 liter of material was expelled from the ruptured vessel. Investigators are assessing recorded experimental data and obtaining specifications from the vessel supplier to determine the probable root causes of the rupture. The facility manager is considering long-term corrective actions that include defining what an emergency mishap or upset condition is, establishing an emergency notification chain, and establishing and communicating hazard response expectations to experimenters.
